**FINAL PHASE I, II AND III
ENVIRONMENTAL SITE ASSESSMENT
MALPEQUE HARBOUR, APPROACH RANGE SITES
LL# 1066, 1067, 1068 and 1069
LDU/PN # 02175, 81101, 02176, 81102
RPIS # MB00064, MB00065, MB00066, MB00067
PRINCE COUNTY, PRINCE EDWARD ISLAND
PROJECT NO. NBF13300-0007**

**JACQUES WHITFORD ENVIRONMENT LIMITED
590 NORTH RIVER ROAD
CHARLOTTETOWN, PEI
C1E 1K1**

January 7, 2002

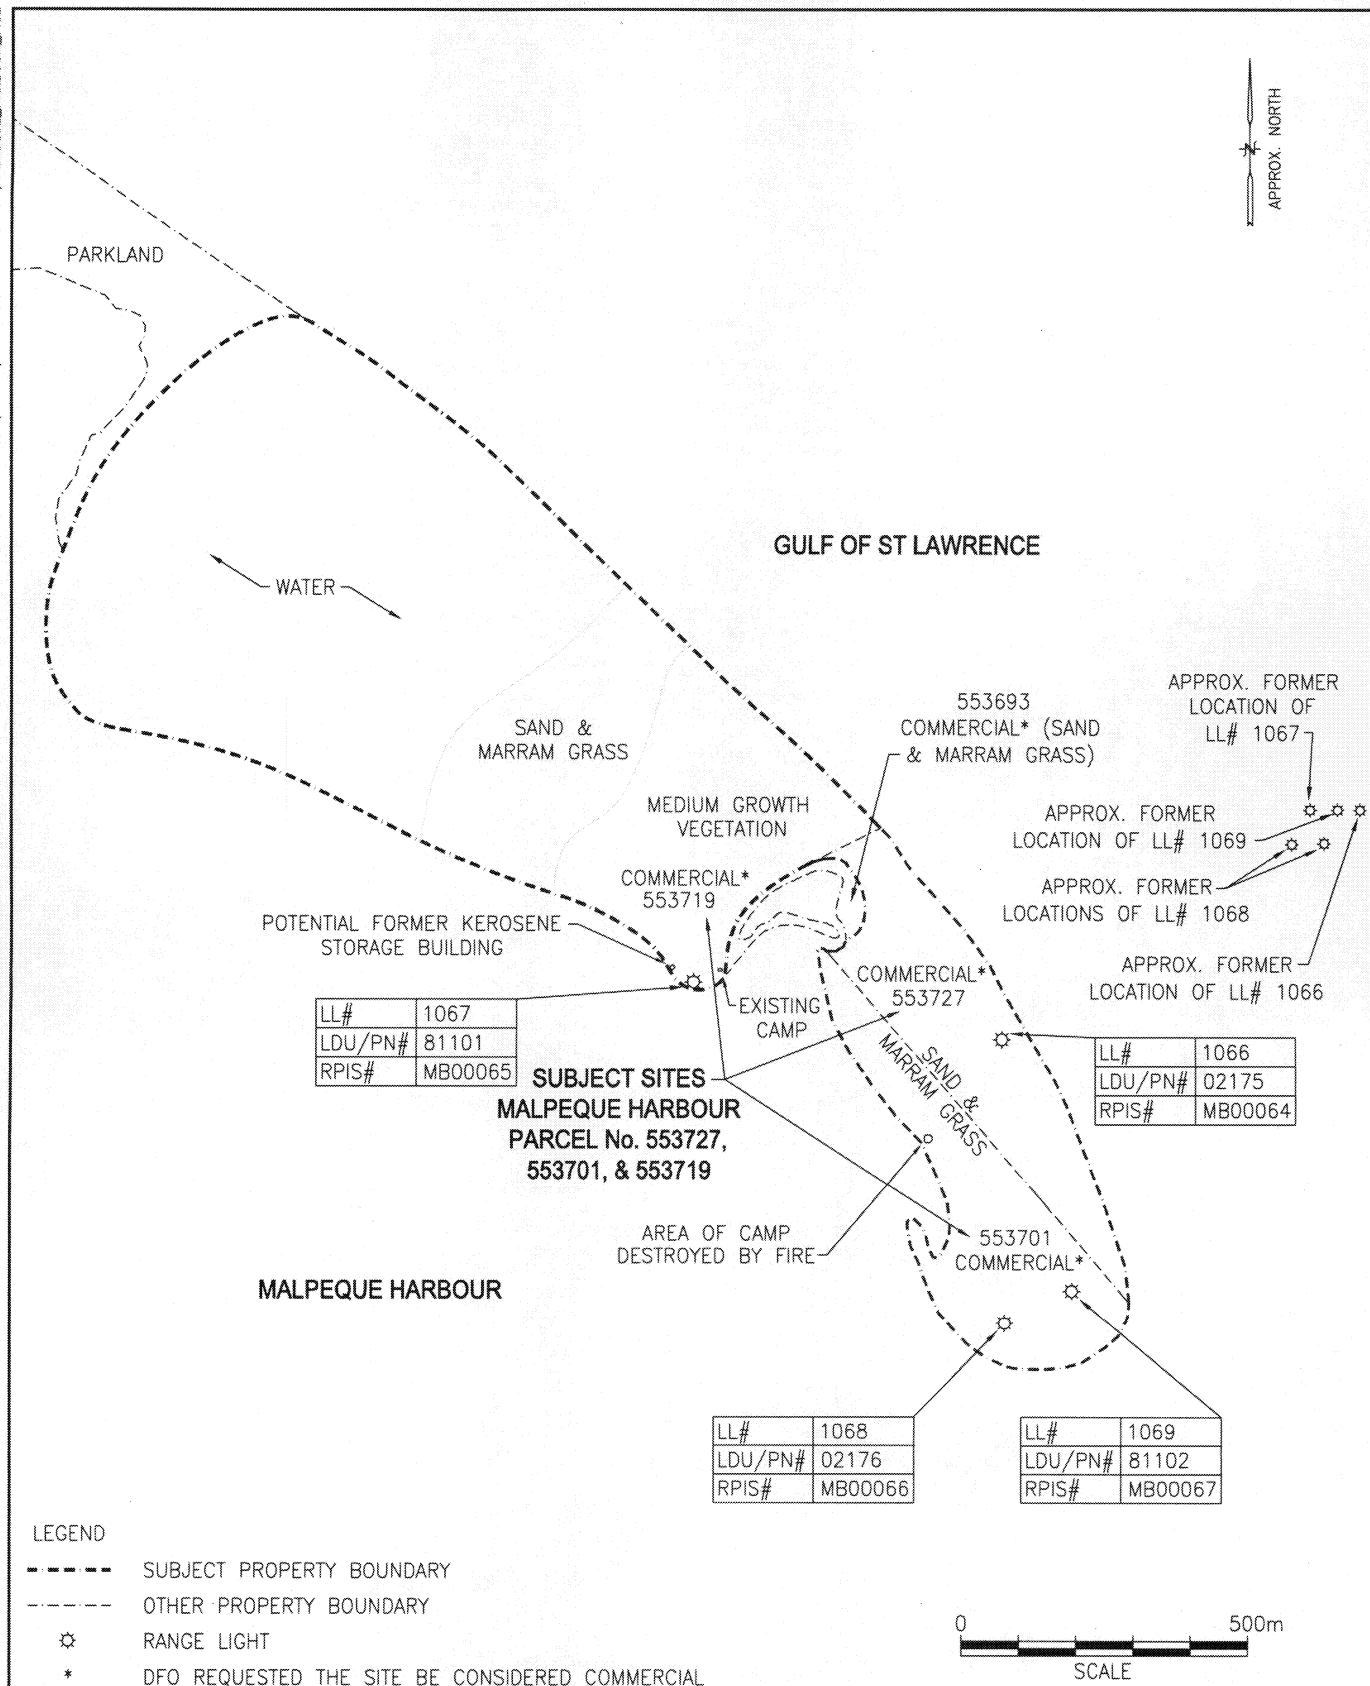
Jacques Whitford Consulting Engineers Environmental Scientists
	Job No.:	13300-07	Figure No.:	2

PROPERTY PLAN MALPEQUE HARBOUR APPROACH RANGE SITES PRINCE COUNTY, PEI, LL#1066, 1067, 1068, 1069, LDU/PN #02175, 81101, 02176, 81102 RPIS#MB00064, MB00065, MB00066, MB00067 DEPARTMENT OF FISHERIES AND OCEANS	Date:	02 01 14	Scale:	1 : 12500

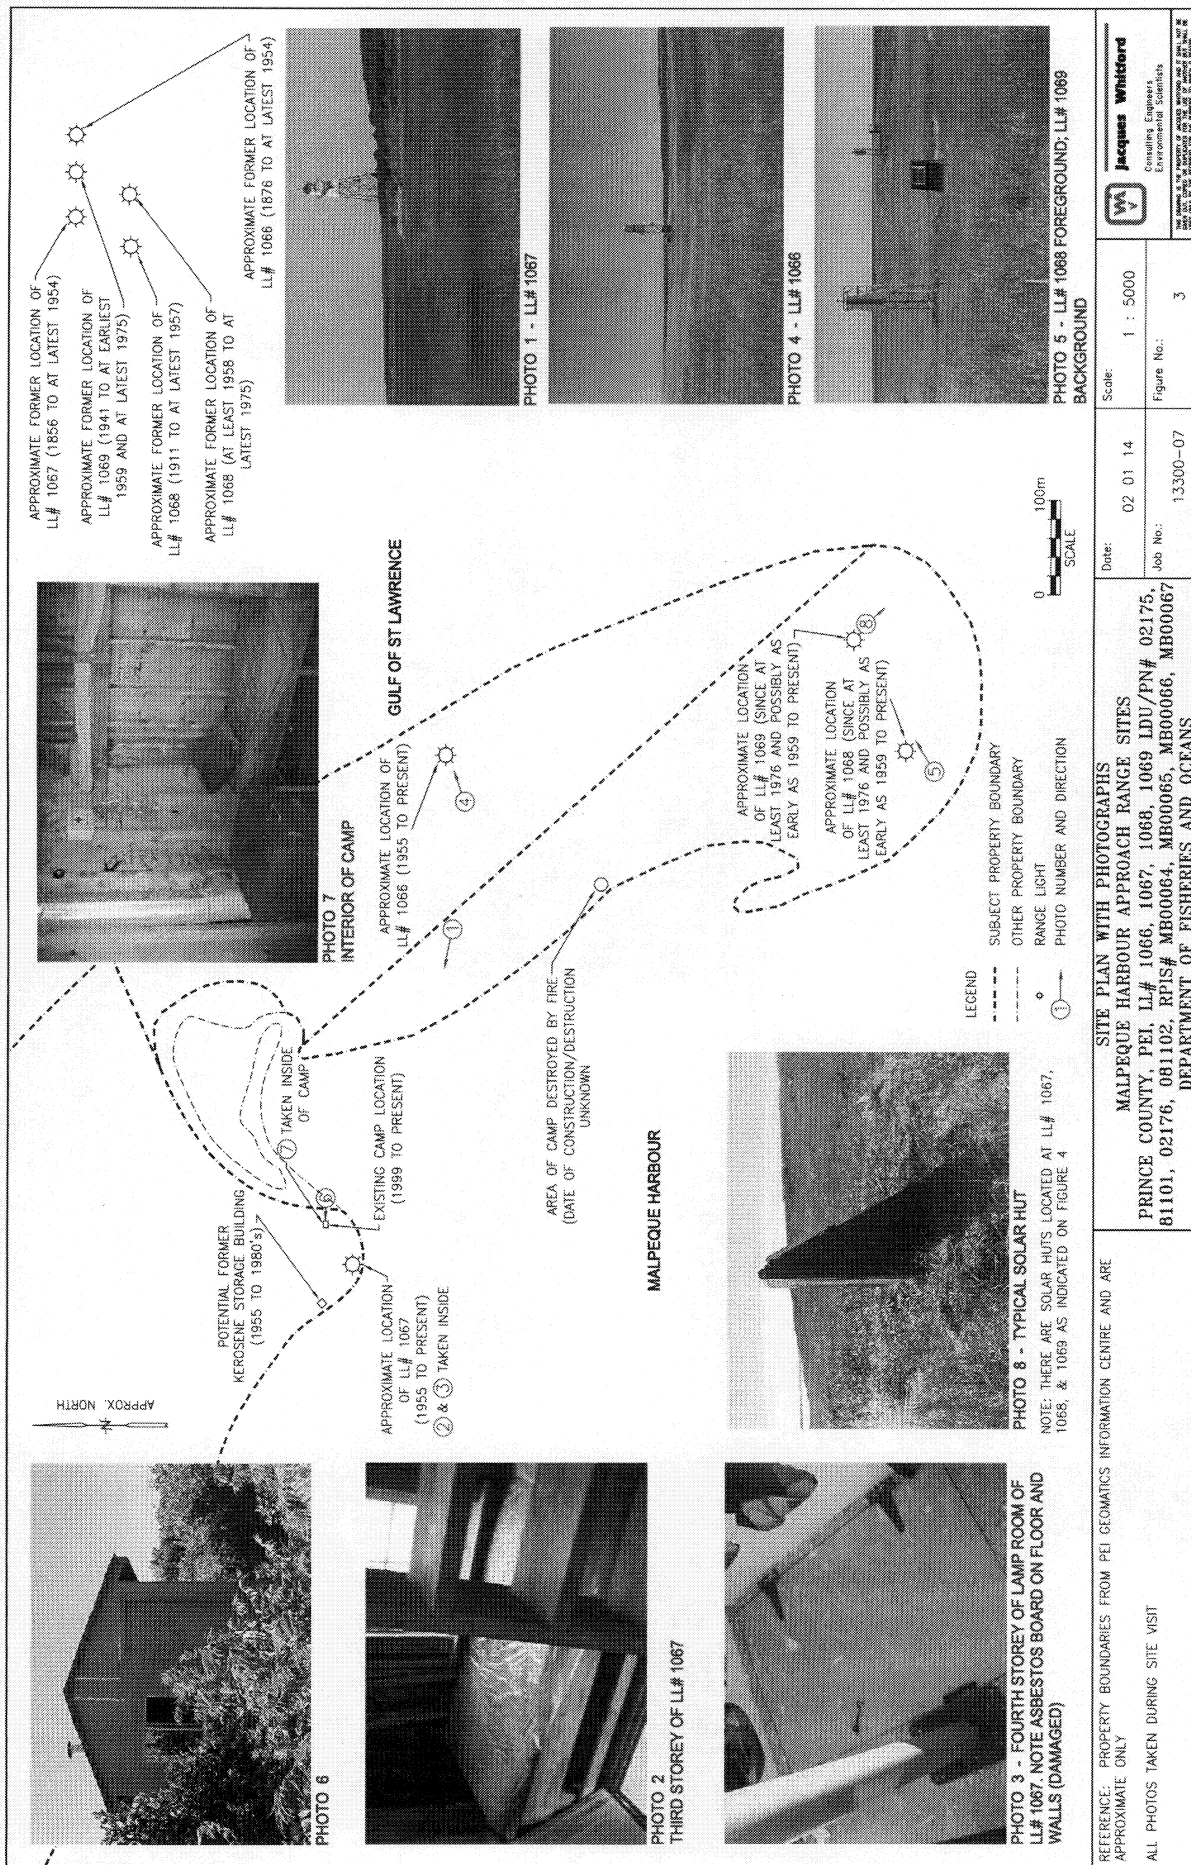
ALL PHOTOS TAKEN DURING SITE VISIT

The subject property was occupied by four range lights, three solar huts, and a camp. Three of the range lights (LL#1068, 1069, and 1066) were skeleton steel towers with wooden daymarks (white with a red vertical stripe) and a light on top of them. A vertical steel ladder was fixed to the skeleton steel towers and enabled access to the steel grate landing, located at the top of the range light, which provided access to the light and the daymark. The skeleton steel range lights had timber skid foundations. The fourth range light (LL#1067) had a two storey metal frame as a base with a two storey wooden enclosed structure on top of it. The range lights were powered by solar energy, which primarily consisted of solar panels and batteries. The batteries for LL#1067, 1068, and 1069 were stored in nearby solar huts, while the batteries for LL#1066 were stored in a red wooden box fixed to the skeleton steel tower.

A metal ladder-type staircase, having a metal landing between the first and second storey, enabled access to the third storey of LL#1067. The third storey of LL#1067 had an unfinished interior and a wooden ladder-type staircase, which enabled access to the fourth storey. A make-shift bed, consisting of fibreglass batt insulation, plastic, and a wooden frame, was observed on the third floor. The interior fourth storey had white painted asbestos board sheathing, which had reportedly been vandalised. Large holes were observed in the asbestos wall sheathing. The floor of the fourth storey was unpainted grey asbestos board. The light for the range was located on the fourth storey. A wooden catwalk having a metal railing was located on the exterior fourth storey of the structure. Painted areas of LL#1067 consisted of the steel framing and ladder-type stair case, the exterior of the upper wooden enclosed portion, and the catwalk steel railing. The roof was covered with asphalt shingles.

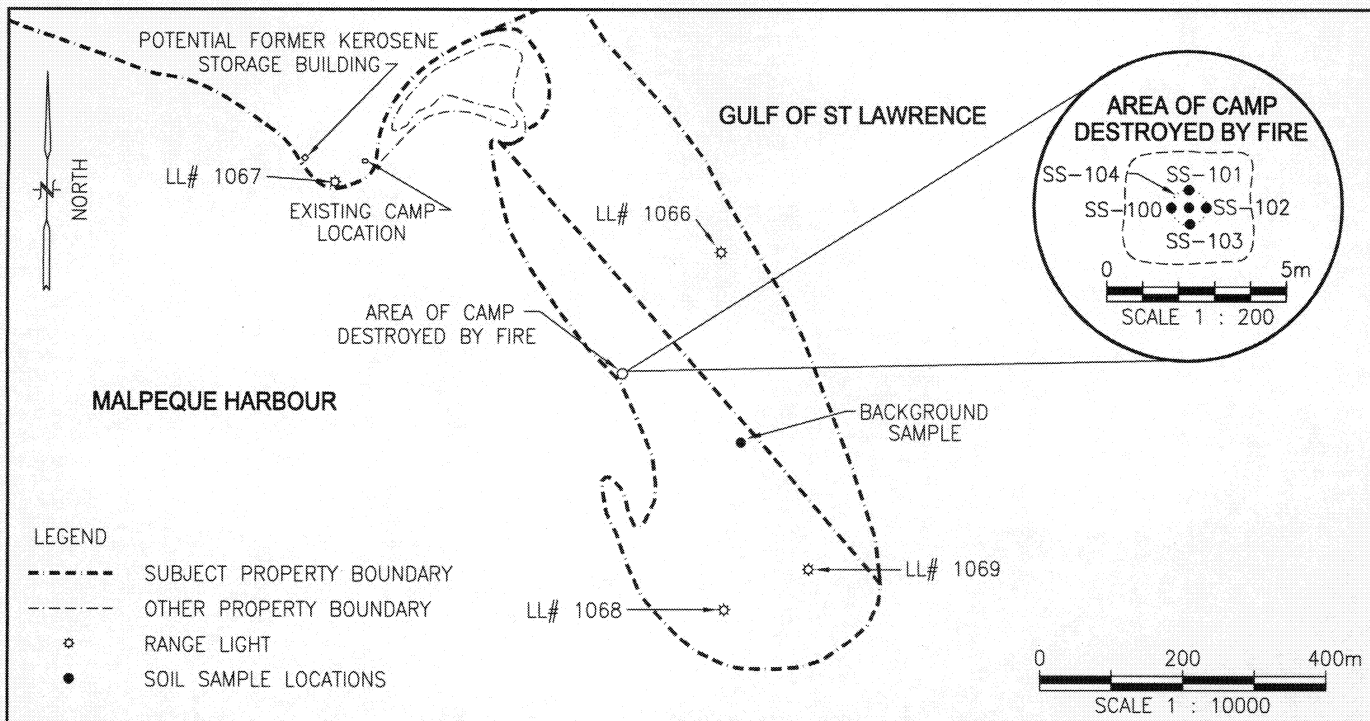
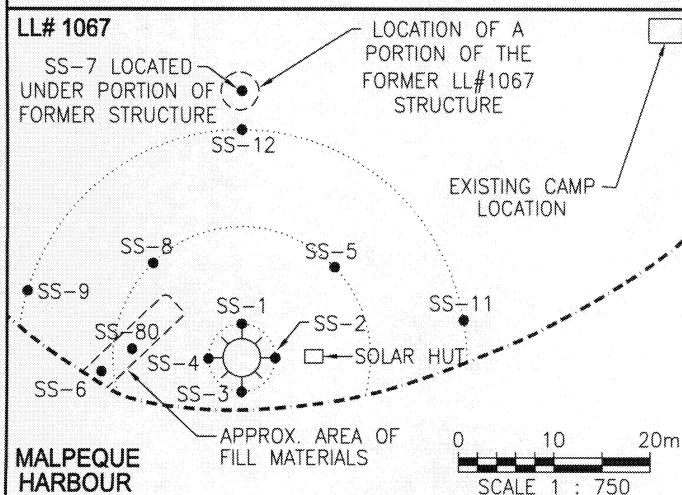
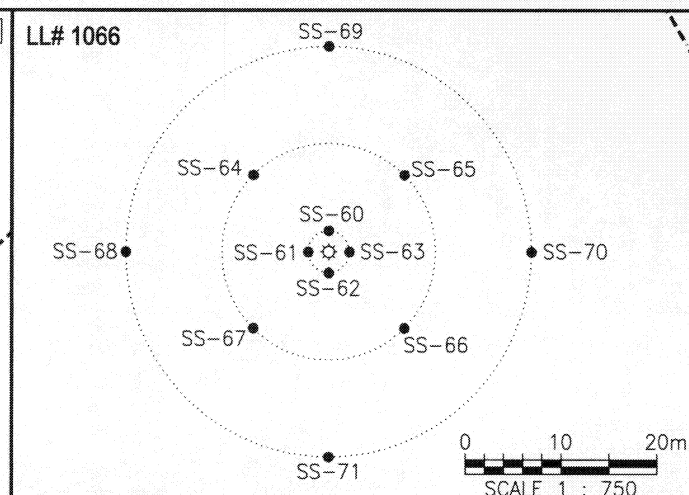
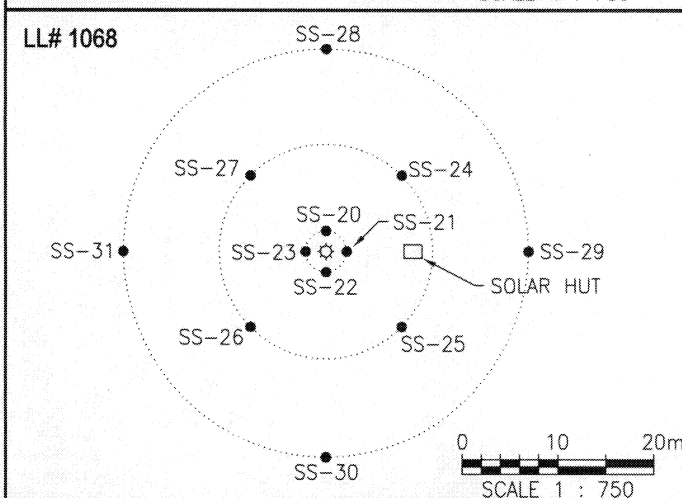
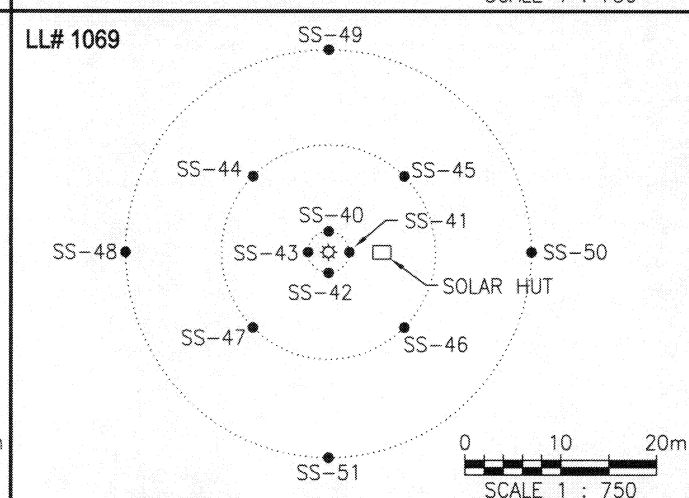
FILE: \13300\07 MALPEQUE HARBOUR\MALPEQUE_HARBOUR_FIG4

<p>SAMPLE LOCATION PLAN</p> <p>MALPEQUE HARBOUR APPROACH RANGE SITES</p> <p>PRINCE COUNTY, PEI, LL#1066, 1067, 1068, 1069,</p> <p>LDU/PN #02175, 81101, 02176, 81102</p> <p>RPIS#MB00064, MB00065, MB00066, MB00067</p> <p>DEPARTMENT OF FISHERIES AND OCEANS</p>	<p>Date:</p> <p>02 01 14</p> <p>Job No.:</p> <p>13300-07</p>	<p>Scale:</p> <p>AS SHOWN</p> <p>Figure No.:</p> <p>4</p>	<p>Jacques Whitford</p> <p>Consulting Engineers Environmental Scientists</p> <p>THIS DRAWING IS THE PROPERTY OF JACQUES WHITFORD AND IT SHALL NOT BE GIVEN OUT, COPIED OR DUPLICATED FOR THE USE OF ANOTHER BUT SHALL BE USED ONLY BY THE RECIPIENT FOR THE PURPOSE TO WHICH IT REFERS.</p>
---	--	---	--

Soil conditions encountered in the test holes were logged by JWEL field personnel at the time of sampling and are described in Section 3.3. The recovered soil samples were placed in glass jars in a cooler for transport back to our office.

In the vicinity of LL#1067, initially only the "A" level samples on the 1 metre ring and SS-6, SS-80, and SS-7 were submitted for soil metal analysis. The initial analytical results indicated lead, zinc and mercury exceedances. Where "A" level exceedances occurred, the "B" and "C" level samples were submitted for analysis of the respective "A" level exceedances. For example, SS-1A had a zinc exceedance, therefore, SS-1B and SS-1C were submitted for zinc analysis. Please note, no exceedances were noted in SS-3A; however, as a precautionary measure, based on proximity to the mercury exceedances on the 1 metre ring and based on the 54% difference from the mean for zinc content, of SS-4A and its blind duplicate, SS-3B and SS-3C were submitted for zinc and mercury analysis.

Samples were collected from depths of 0 to 0.45 mbgs. The majority of the overburden on the site consisted of light brown to reddish brown sand, excluding the area of LL#1067, which consisted of reddish brown silty sand and areas of fill material. The suspected source of the fill material was the demolition/destruction of the original LL#1067 structure and attached dwelling. Debris observed in the fill material at SS-80 and SS-6 included brick, glass, dishes, and a paint can. Bedrock was not encountered.

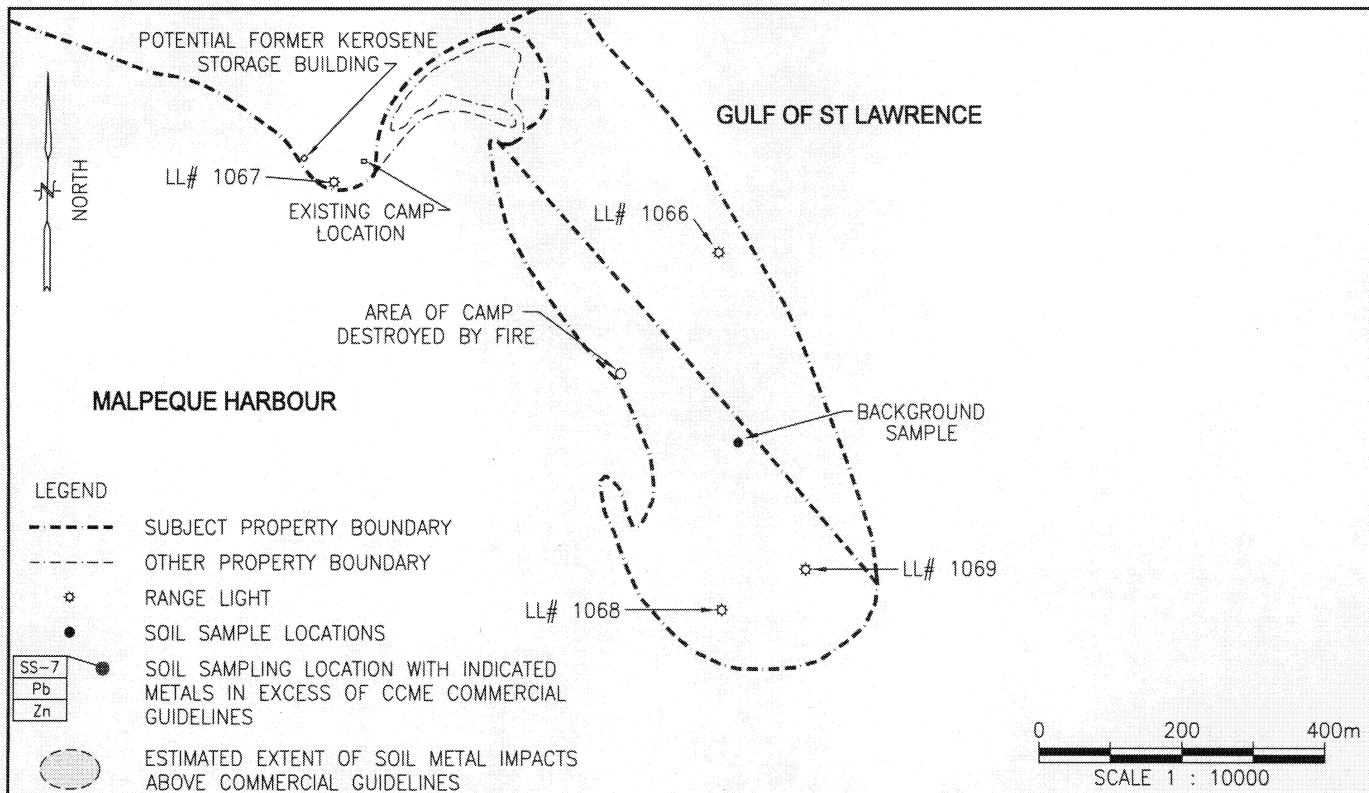
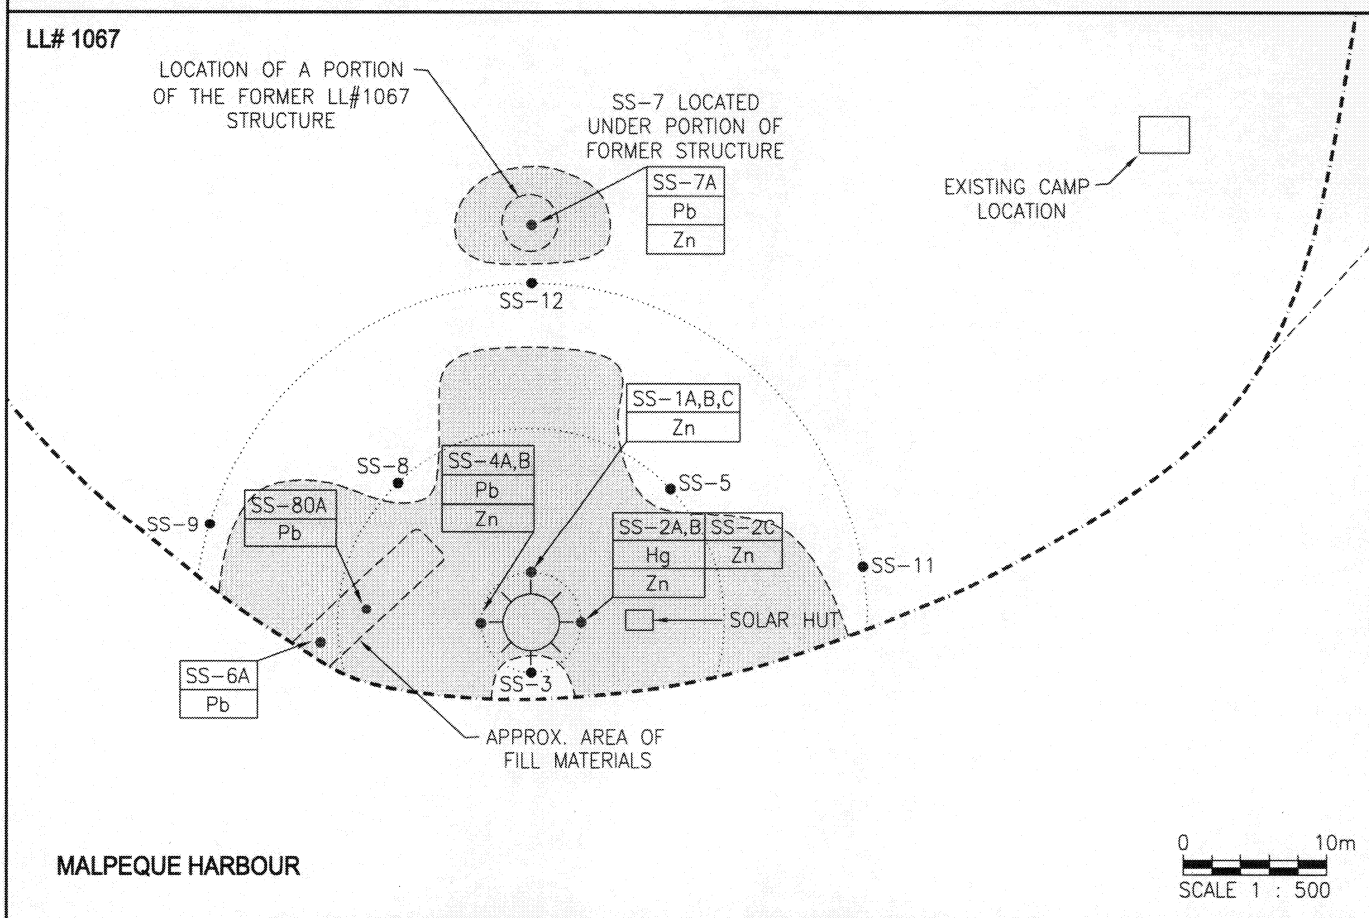
FILE: \13300\07 MALPEQUE HARBOUR\MALPEQUE_FIG5

- lead, zinc and mercury concentrations above the CCME commercial values were found in soil samples on the 1 m and 10 m ring around LL#1067, as well as at three soil sample locations in the vicinity of LL#1067 where the potential for contamination was suspected based on the presence of fill material and a portion of the former LL#1067 structure. The volume of contaminated soil is estimated as 175 m³. Further on site delineation would be required to delineate one area;
- paint at LL#1067 and LL#1066 exceed the Hazardous Products Regulations for lead of 5,000 mg/kg

<p>ESTIMATED EXTENT OF SOIL METAL IMPACTS MALPEQUE HARBOUR APPROACH RANGE SITES PRINCE COUNTY, PEI, LL#1066, 1067, 1068, 1069, LDU/PN #02175, 81101, 02176, 81102 RPIS#MB00064, MB00065, MB00066, MB00067 DEPARTMENT OF FISHERIES AND OCEANS</p>	<p>Date: 02 01 14</p> <p>Job No.: 13300-07</p>	<p>Scale: AS SHOWN</p> <p>Figure No.: 5</p>	<p>Jacques Whitford Consulting Engineers Environmental Scientists</p> <p><small>THIS DRAWING IS THE PROPERTY OF JACQUES WHITFORD AND IT SHALL NOT BE GIVEN OUT, COPIED OR DUPLICATED FOR THE USE OF ANOTHER BUT SHALL BE USED ONLY BY THE RECIPIENT FOR THE PURPOSE TO WHICH IT REFERS.</small></p>
---	--	---	--

Issue	Comment	Recommendation
Horizontal Extent of Contamination	640 m ² impacted area around LL#1067. Assumed 60 m ² impacted area around SS 7.	Further on site delineation is required in the vicinity of SS-7.
Off site impacts?	Not expected.	None
Vertical Extent of Contamination	Maximum depth of soil contamination is 0.45 mbgs. Average depth of soil contamination is 0.25 mbgs.	Vertical extent is generally delineated in the vicinity of LL#1067 and the concentric ring locations. Vertical delineation is required in the vicinity of SS-7, SS-1 and SS-2.
Summary	Approximate volume of contaminated soil identified is 175 m ³ . Contaminant distribution is consistent with identified sources. Groundwater was not encountered; therefore, no groundwater concerns were identified.

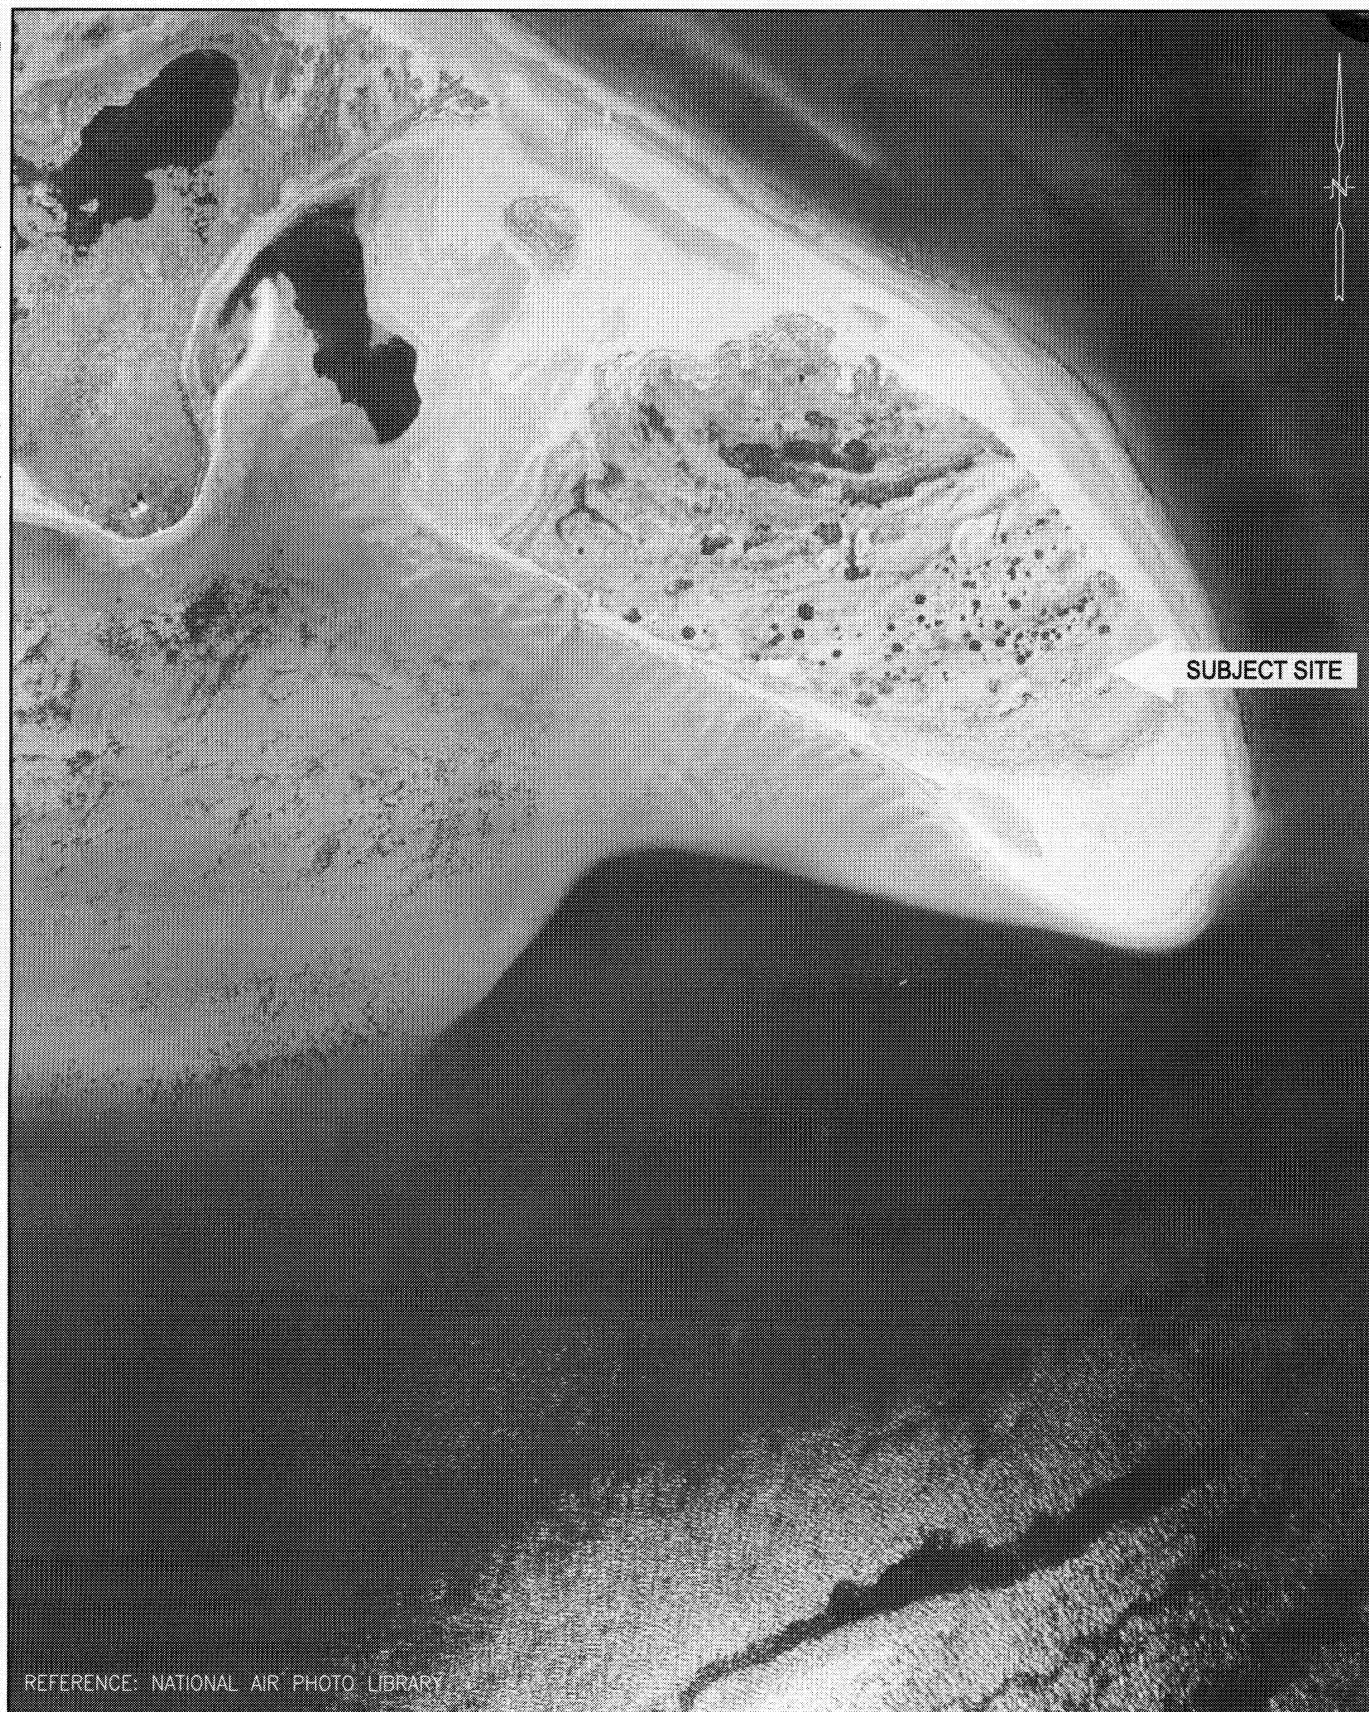
<p align="center">1955 AERIAL PHOTOGRAPH MALPEQUE HARBOUR APPROACH RANGE SITES PRINCE COUNTY, PEI, LL# 1066, 1067, 1068, 1069 LDU/PN# 02175, 81101, 02176, 81102 RPIS# MB00064, MB00065, MB00066, MB00067 DEPARTMENT OF FISHERIES AND OCEANS</p>	<p>Date: 02 01 14</p>	<p>Scale: NTS</p>	<p align="center">

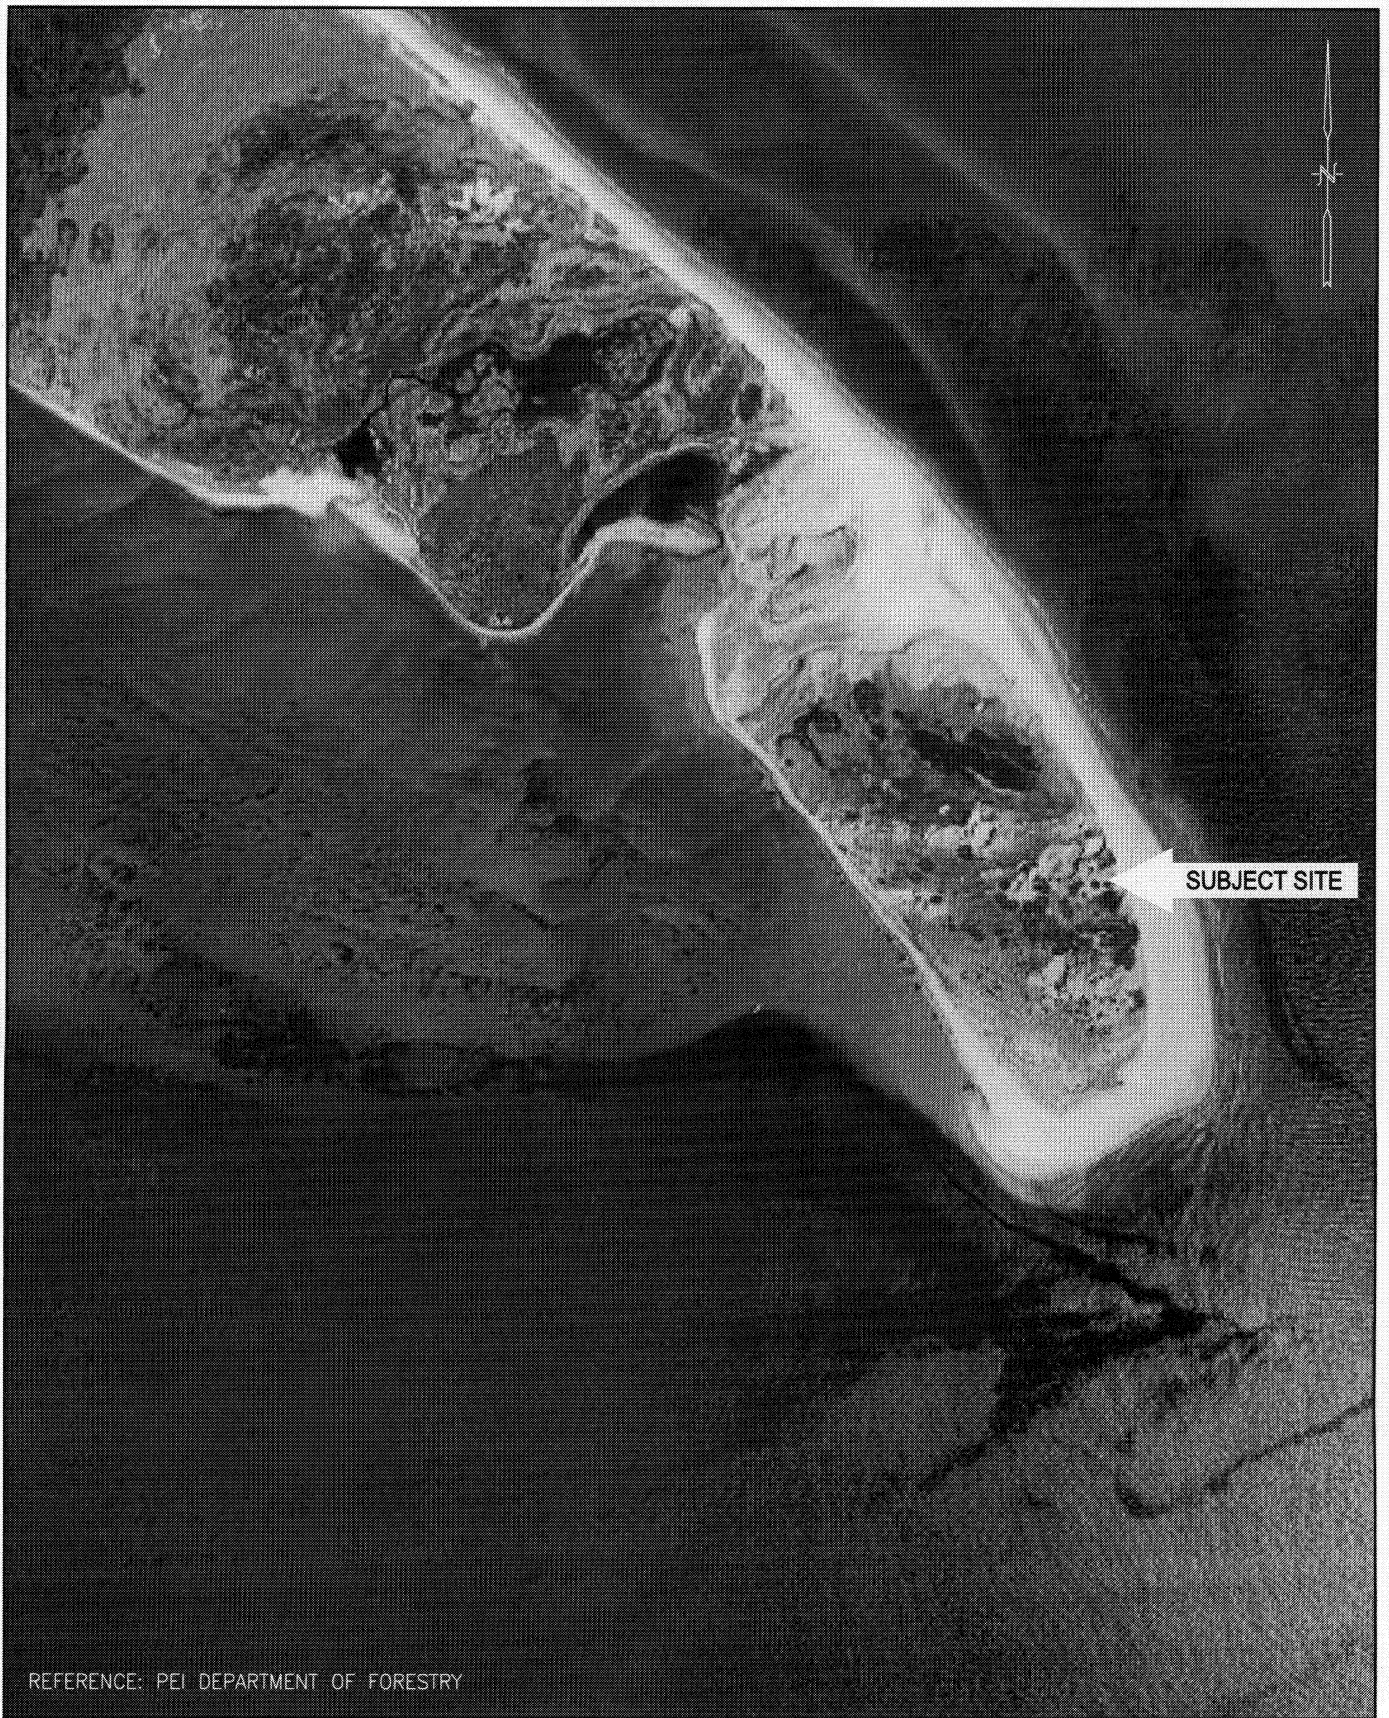
<p>1974 AERIAL PHOTOGRAPH MALPEQUE HARBOUR APPROACH RANGE SITES PRINCE COUNTY, PEI, LL# 1066, 1067, 1068, 1069 LDU/PN# 02175, 81101, 02176, 81102 RPIS# MB00064, MB00065, MB00066, MB00067 DEPARTMENT OF FISHERIES AND OCEANS</p>	<p>Date: 02 01 14</p>	<p>Scale: NTS</p>	<p>

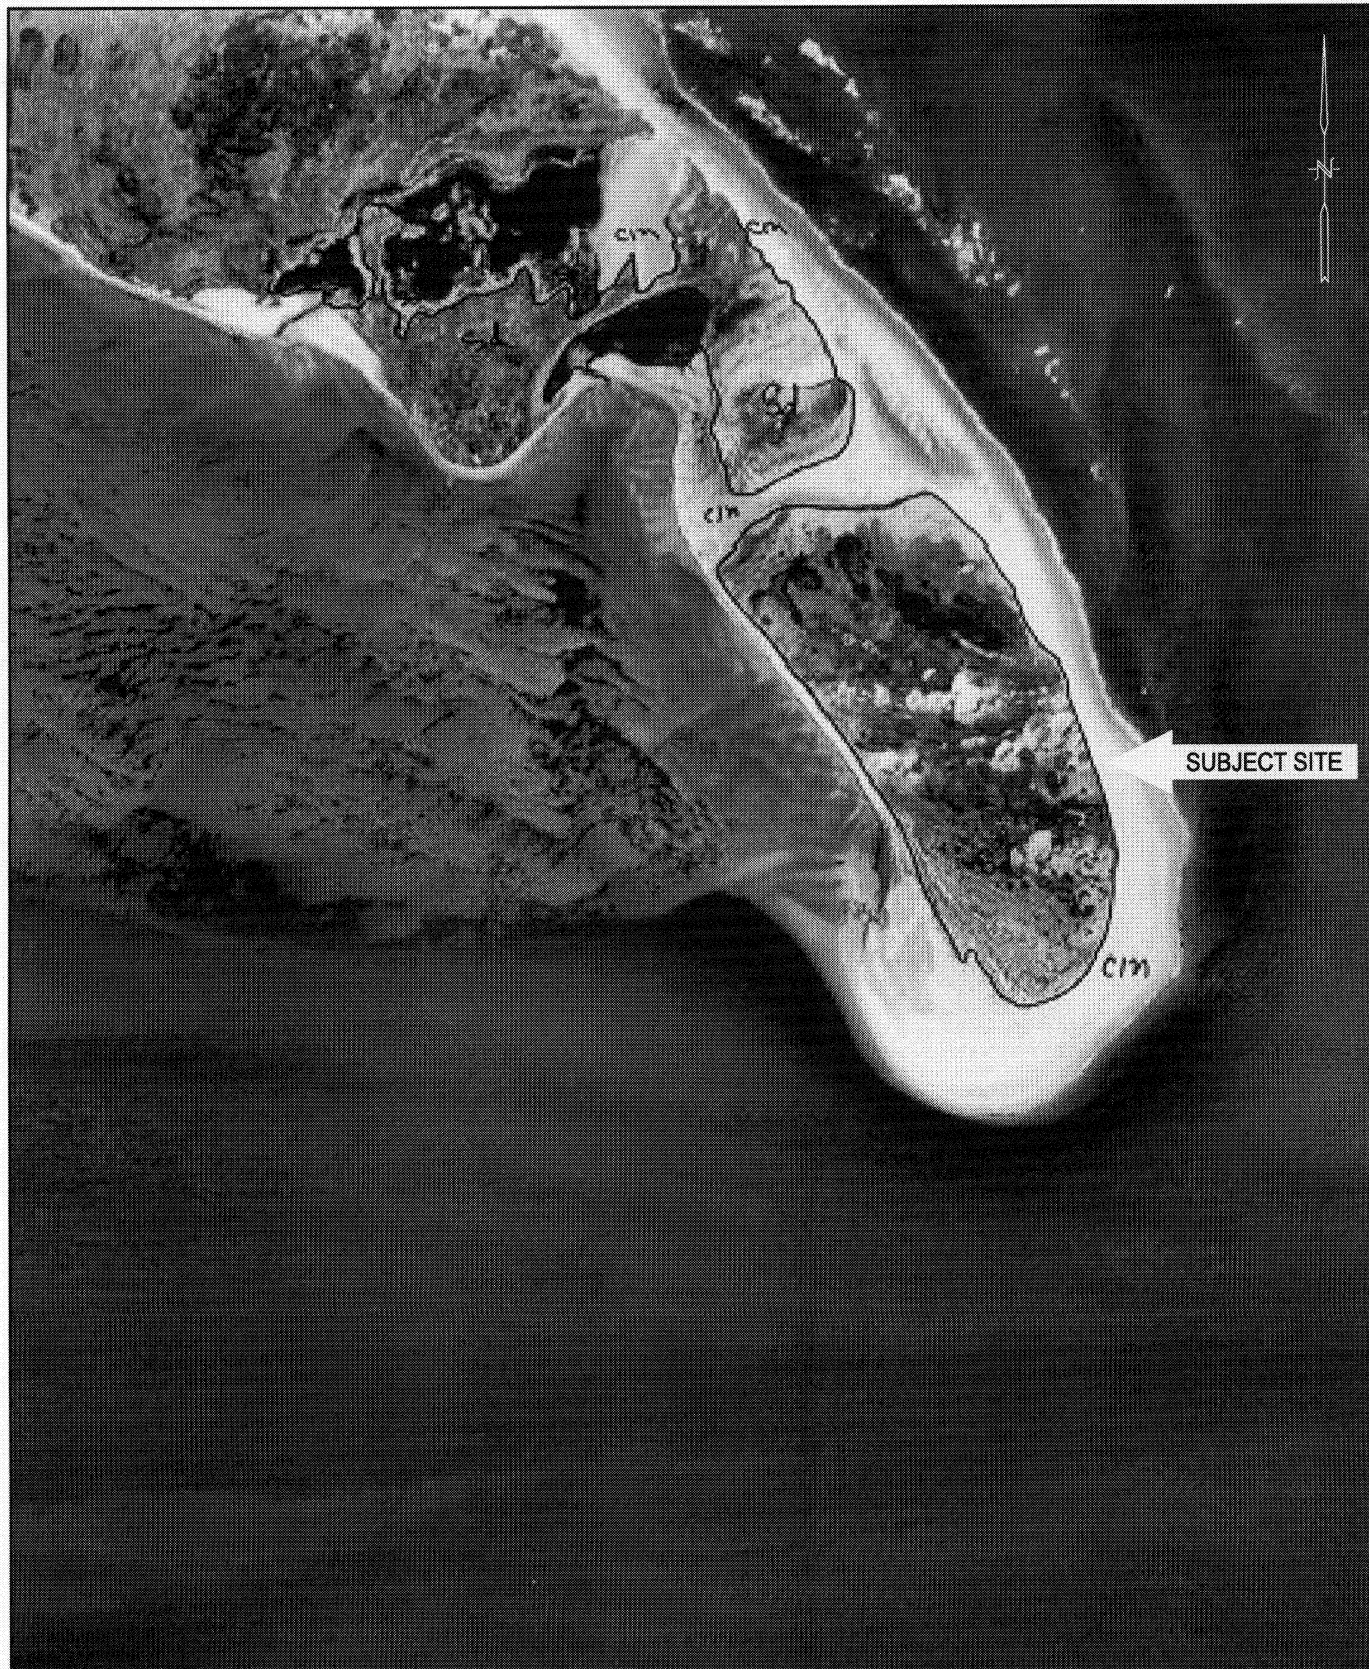
<p>1980 AERIAL PHOTOGRAPH MALPEQUE HARBOUR APPROACH RANGE SITES PRINCE COUNTY, PEI, LL# 1066, 1067, 1068, 1069 LDU/PN# 02175, 81101, 02176, 81102 RPIS# MB00064, MB00065, MB00066, MB00067 DEPARTMENT OF FISHERIES AND OCEANS</p>	<p>Date: 02 01 14</p> <p>Job No.: 13300-07</p>	<p>Scale: NTS</p> <p>PHOTO No.: 12</p>	<div data-bbox="1208 1789 1273 1852"> </div> <p>Jacques Whitford Consulting Engineers Environmental Scientists</p> <p><small>THIS DRAWING IS THE PROPERTY OF JACQUES WHITFORD AND IT SHALL NOT BE GIVEN OUT, COPIED OR DUPLICATED FOR THE USE OF ANOTHER BUT SHALL BE USED ONLY BY THE RECIPIENT FOR THE PURPOSE TO WHICH IT REFERS.</small></p>
---	--	--	---

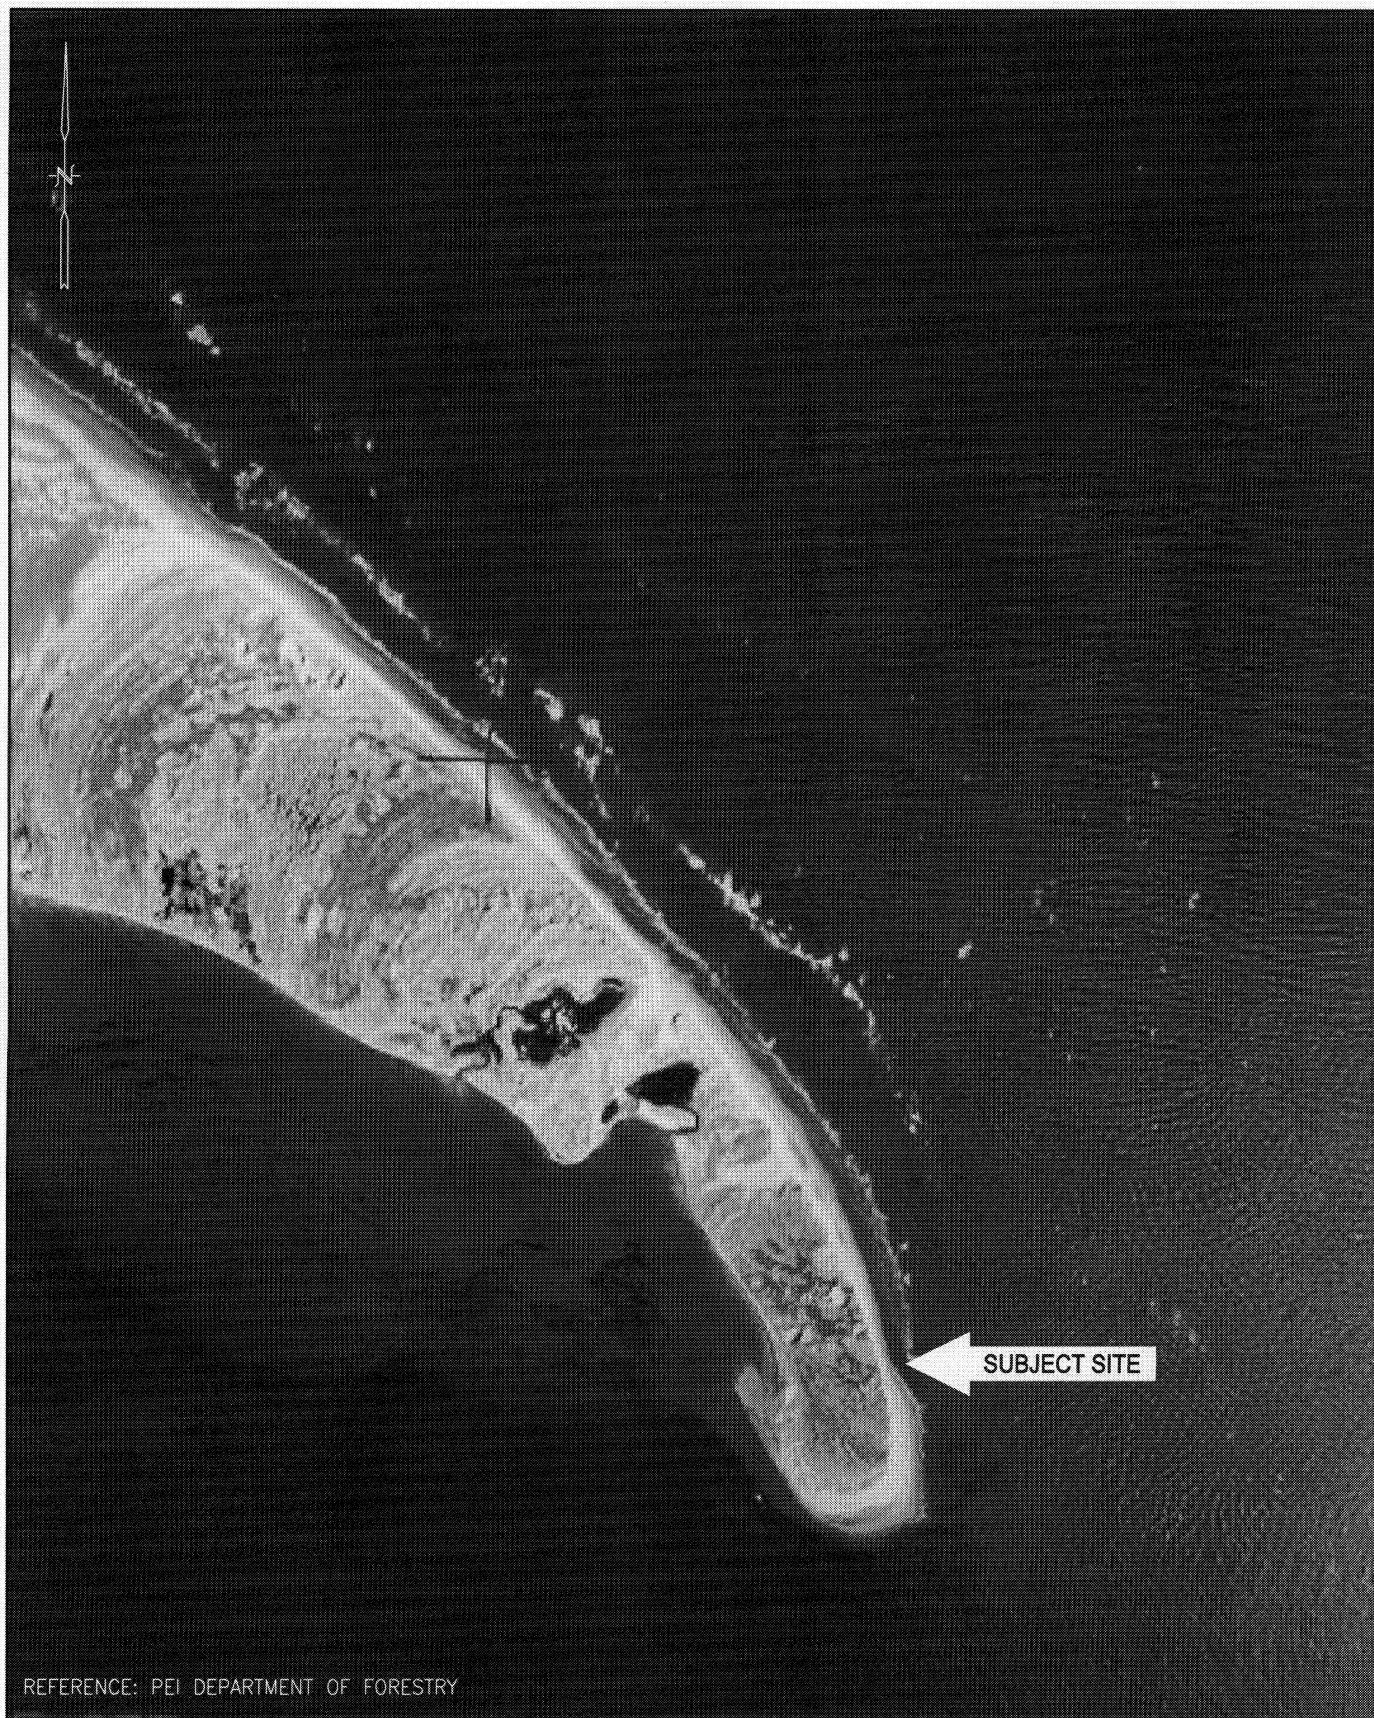
<p align="center">1990 AERIAL PHOTOGRAPH MALPEQUE HARBOUR APPROACH RANGE SITES PRINCE COUNTY, PEI, LL# 1066, 1067, 1068, 1069 LDU/PN# 02175, 81101, 02176, 81102 RPIS# MB00064, MB00065, MB00066, MB00067 DEPARTMENT OF FISHERIES AND OCEANS</p>	Date: 02 01 14	Scale: NTS	<div data-bbox="1201 1785 1274 1858" style="display: inline-block; border: 1px solid black; padding: 2px; text-align: center;"> WV </div> <p>Jacques Whitford Consulting Engineers Environmental Scientists</p> <p><small>THIS DRAWING IS THE PROPERTY OF JACQUES WHITFORD AND IT SHALL NOT BE GIVEN OUT, COPIED OR DUPLICATED FOR THE USE OF ANOTHER BUT SHALL BE USED ONLY BY THE RECIPIENT FOR THE PURPOSE TO WHICH IT REFERS.</small></p>
	Job No.: 13300-07	PHOTO No.: 13
